**Flood Control Project Maintenance
Levee Inspections**
LMA District Cover Sheet
Spring 2010 Levee Inspection Results

Reclamation District No. 0537 Lovdal

Spring 2010 Levee Inspection Results

Waterway			Bank	Unit Miles
Unit No. 01 Sacramento River			Right	4.76
	Spring (March - May)	Summer (June - August)	(September - November) Fall	Winter (December - February)
Unit Maintenance Rating (Fall Only)				
Date of Inspection	5/12/2010 - 5/12/2010			
DWR Inspector	John Williamson			
Accompanied By	Jim Eckman

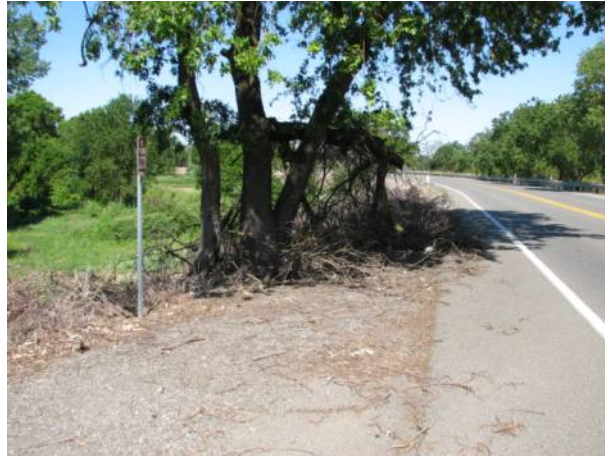
Levee Mile Report Line	11
Start Levee Mile	0.77
End Levee Mile	0.77
Location	Land Side
Category	Earthen Levee
Item	Encroachments

branches lying on shoulder

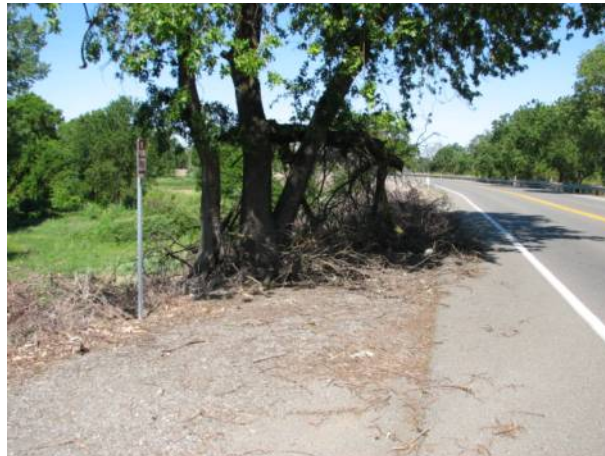
Levee Mile Report Line	11
Start Levee Mile	0.77
End Levee Mile	0.77
Location	Land Side
Category	Earthen Levee
Item	Encroachments

tree branches along shoulder

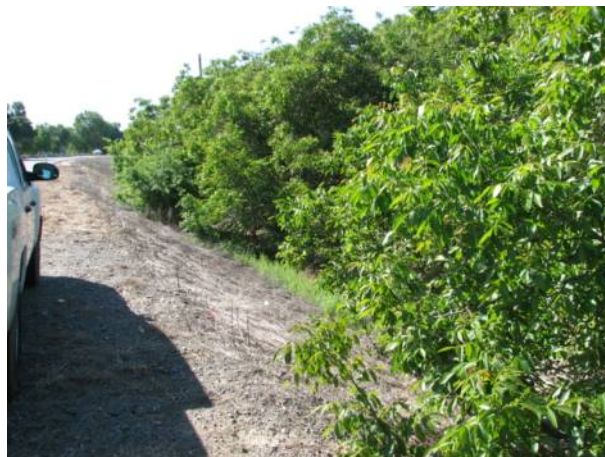
Levee Mile Report Line	12
Start Levee Mile	1.06
End Levee Mile	1.06
Location	Land Side
Category	Earthen Levee
Item	Trim / Thin Trees

trees needed to be raised

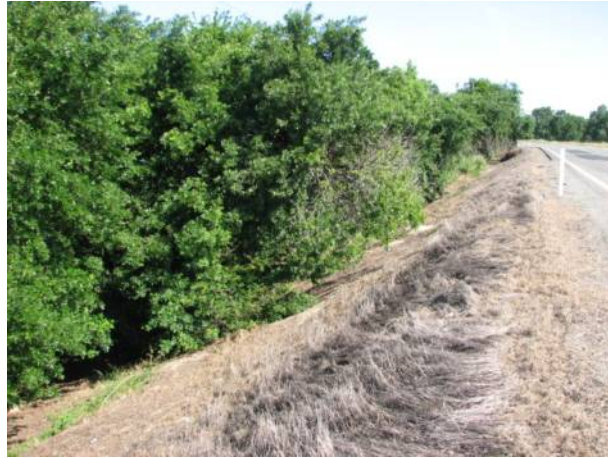
Levee Mile Report Line	14
Start Levee Mile	1.93
End Levee Mile	1.93
Location	Land Side
Category	Earthen Levee
Item	Trim / Thin Trees

14	1.93	1.93	Earthen Levee	Trim / Thin Trees	LS	M	Trim trees to at least five feet above ground level.	38.633141 ° -121.564497 °	38.633141 ° -121.564497 °	5 Y
15	1.94	2.11	Earthen Levee	Vegetation	LS	W	Control annual grass and weeds on the levee slopes and easements.	38.632859 ° -121.564506 °	38.630553 ° -121.564239 °	964
16	2.31	2.47	Earthen Levee	Vegetation	LS	W	Control annual grass and weeds on the levee slopes and easements.	38.627704 ° -121.563917 °	38.625574 ° -121.563733 °	965
17	2.58	2.64	Earthen Levee	Encroachments	LS	PO	Landscaping	38.623988 ° -121.563663 °	38.623067 ° -121.563580 °	1

trees need to be raised to 5'

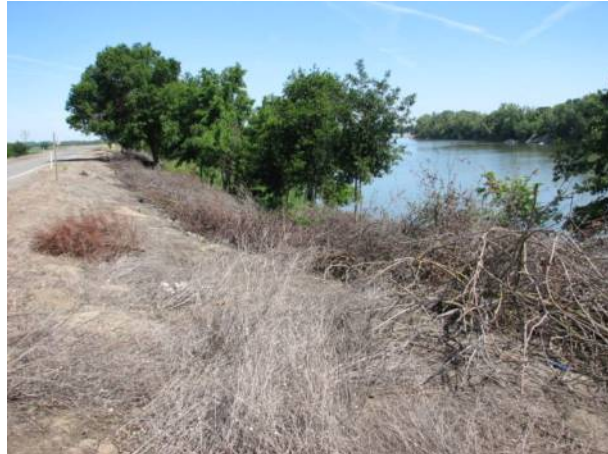
Levee Mile Report Line	21
Start Levee Mile	3.67
End Levee Mile	3.67
Location	Water Side
Category	Earthen Levee
Item	Encroachments

piles of prunnings

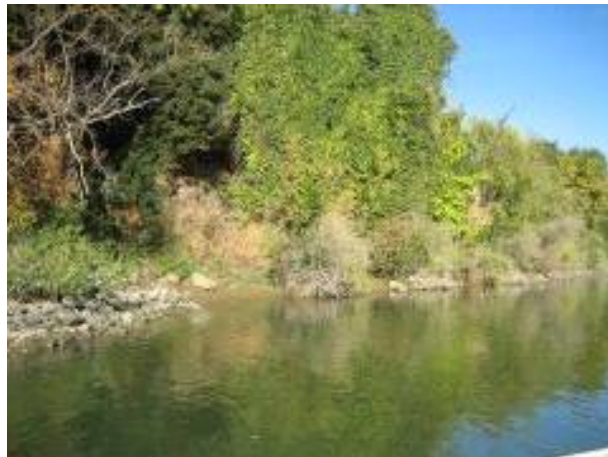
Levee Mile Report Line	23
Start Levee Mile	4.28
End Levee Mile	4.31
Location	Water Side
Category	Supplemental
Item	USACE Erosion Survey

23	4.28	4.31	Supplemental Survey	USACE Erosion	WS	M	Inspector Comments: 2009: 15 ft berm, 1.5:1 slope, tree hazards and slumping, clays and silts, 2.87 ft/s [2009 SiteID:SAC_63-0_R]	38.602142 ° -121.553839 °	38.601747 ° -121.553531 °	18 Y
24	4.34	4.38	Supplemental Survey	USACE Erosion	WS	U	Inspector Comments: 2009: 10 ft berm, 1:1 slope, tree hazards and slumping, clays and silts, 3.08 ft/s [2009 SiteID:SAC_62-9_R]	38.601389 ° -121.553250 °	38.600908 ° -121.552814 °	19 Y
25	4.38	4.53	Earthen Levee	Vegetation	WS	W	Remove the wild growth other than native grasses from the levee slopes.	38.600657 ° -121.553082 °	38.598918 ° -121.551242 °	7
26	4.41	4.41	Earthen Levee	Encroachments	WS	M	Prunings	38.600233 ° -121.552578 °	38.600233 ° -121.552578 °	13 Y
27	4.43	4.43	Earthen Levee	Encroachments	LS	M	Debris	38.599926 ° -121.552352 °	38.599926 ° -121.552352 °	6 Y
28	4.48	4.53	Earthen Levee	Vegetation	WS	C	Remove the wild growth other than native grasses from the levee slopes.	38.599469 ° -121.551813 °	38.598842 ° -121.551131 °	953

2009: 15 ft berm, 1.5:1 slope, tree hazards and slumping, clays and silts, 2.87 ft/s [2009 SiteID:SAC_63-0_R]

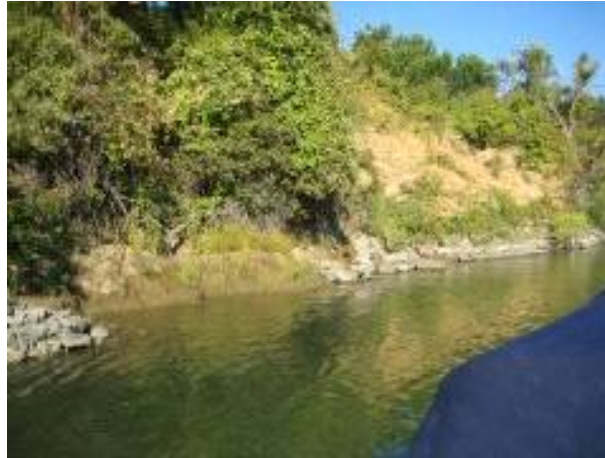
Levee Mile Report Line	24
Start Levee Mile	4.34
End Levee Mile	4.38
Location	Water Side
Category	Supplemental
Item	USACE Erosion Survey
2009: 10 ft berm, 1:1 slope, tree hazards and slumping, clays and silts, 3.08 ft/s [2009 SiteID:SAC_62-9_R]	
USACE2009_SAC_62-9_R_2009_09_17-D3P06_small.JPG

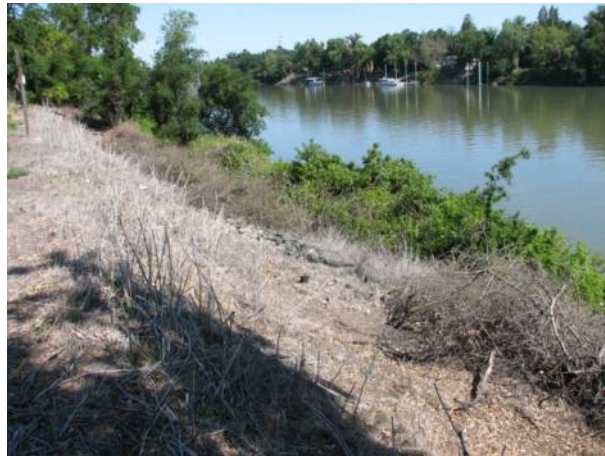
Levee Mile Report Line	26
Start Levee Mile	4.41
End Levee Mile	4.41
Location	Water Side
Category	Earthen Levee
Item	Encroachments
piles of prunings	
johnwg_s_20100512_175.jpg

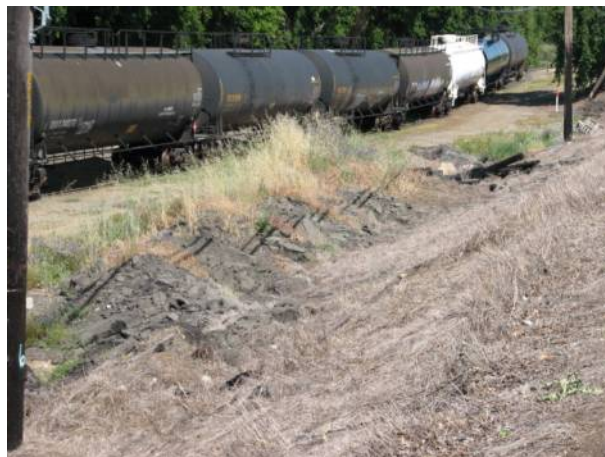
Levee Mile Report Line	27
Start Levee Mile	4.43
End Levee Mile	4.43
Location	Land Side
Category	Earthen Levee
Item	Encroachments
asphalt and railroad rails	
johnwg_s_20100512_171.jpg

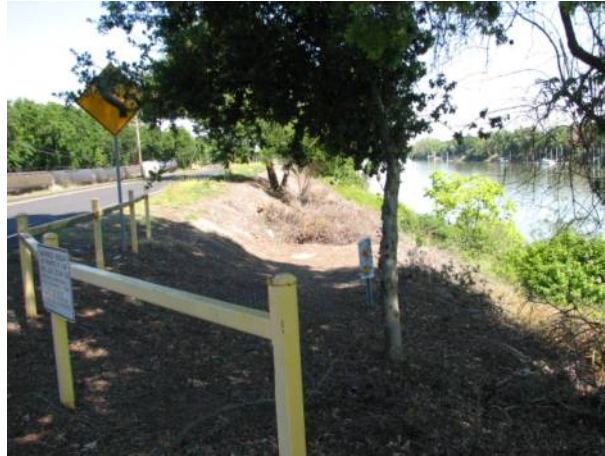
Levee Mile Report Line	29
Start Levee Mile	4.51
End Levee Mile	4.51
Location	Water Side
Category	Earthen Levee
Item	Encroachments

piles of prunnings

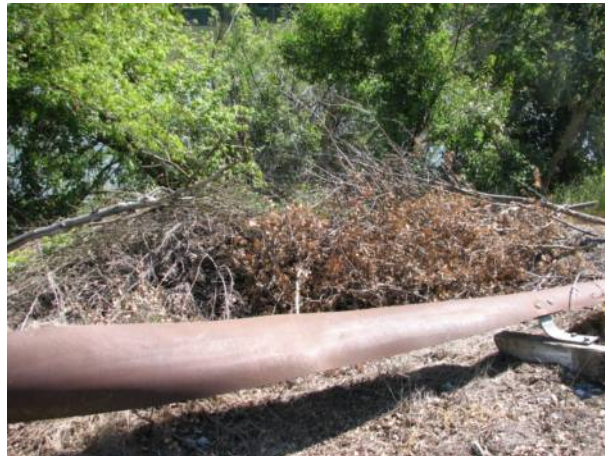
Levee Mile Report Line	30
Start Levee Mile	4.56
End Levee Mile	4.56
Location	Water Side
Category	Earthen Levee
Item	Encroachments

prunnings left in piles

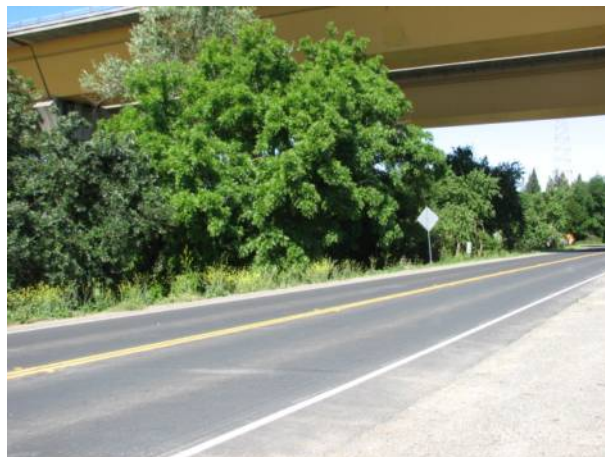
Levee Mile Report Line	31
Start Levee Mile	4.74
End Levee Mile	4.74
Location	Land Side
Category	Earthen Levee
Item	Trim / Thin Trees

29	4.51	4.51	Earthen Levee	Encroachments	WS	M	Prunings	38.599115 ° -121.551412 °	38.599115 ° -121.551412 °	12 Y
30	4.56	4.56	Earthen Levee	Encroachments	WS	M	Prunings	38.598622 ° -121.550905 °	38.598622 ° -121.550905 °	11 Y
31	4.74	4.74	Earthen Levee	Trim / Thin Trees	LS	M	Trim trees to at least five feet above ground level.	38.596958 ° -121.548052 °	38.596958 ° -121.548052 °	10 Y

trees need to be trimmed

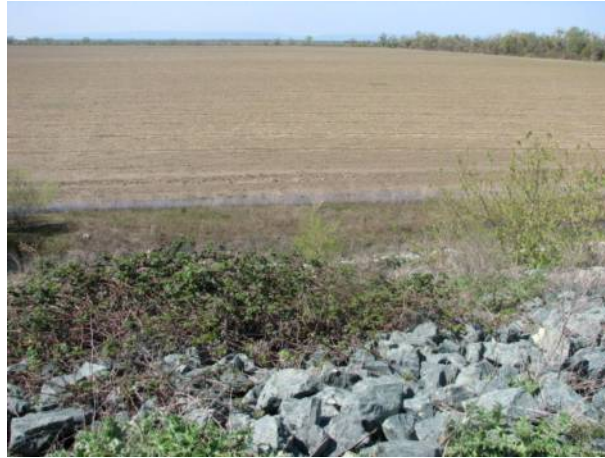
Levee Mile Report Line	2
Start Levee Mile	0.19
End Levee Mile	0.19
Location	Water Side
Category	Earthen Levee
Item	Vegetation

Berries and small willow in rip-rap

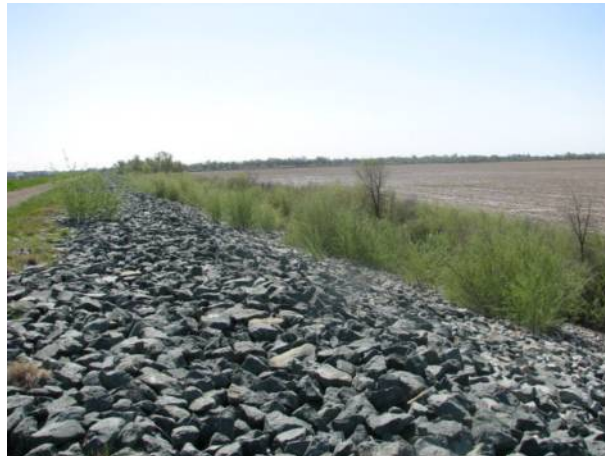
Levee Mile Report Line	3
Start Levee Mile	0.37
End Levee Mile	0.37
Location	Water Side
Category	Earthen Levee
Item	Trim / Thin Trees

willows need to be sprayed and removed

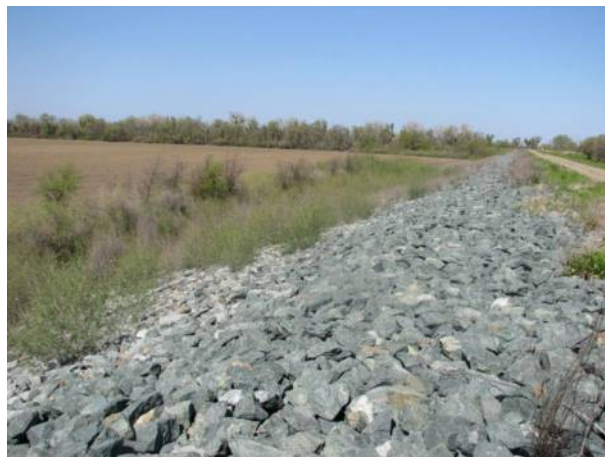
Levee Mile Report Line	3
Start Levee Mile	0.37
End Levee Mile	0.37
Location	Water Side
Category	Earthen Levee
Item	Trim / Thin Trees

willows looking up stream; need to remove willows

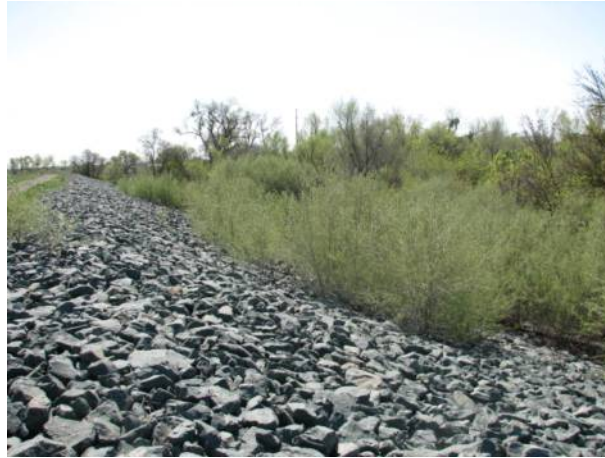
Levee Mile Report Line	4
Start Levee Mile	1.00
End Levee Mile	1.00
Location	Water Side
Category	Earthen Levee
Item	Trim / Thin Trees

4	1.00	1.00	Earthen Levee	Trim / Thin Trees	WS	M	Trim and thin trees to allow visibility of the ground and room to flood fight. Inspector Comments: cut and spray willows in rock area	38.584025 ° -121.569861 °	38.584025 ° -121.569861 °	1 Y

willows need to be sprayed and removed
